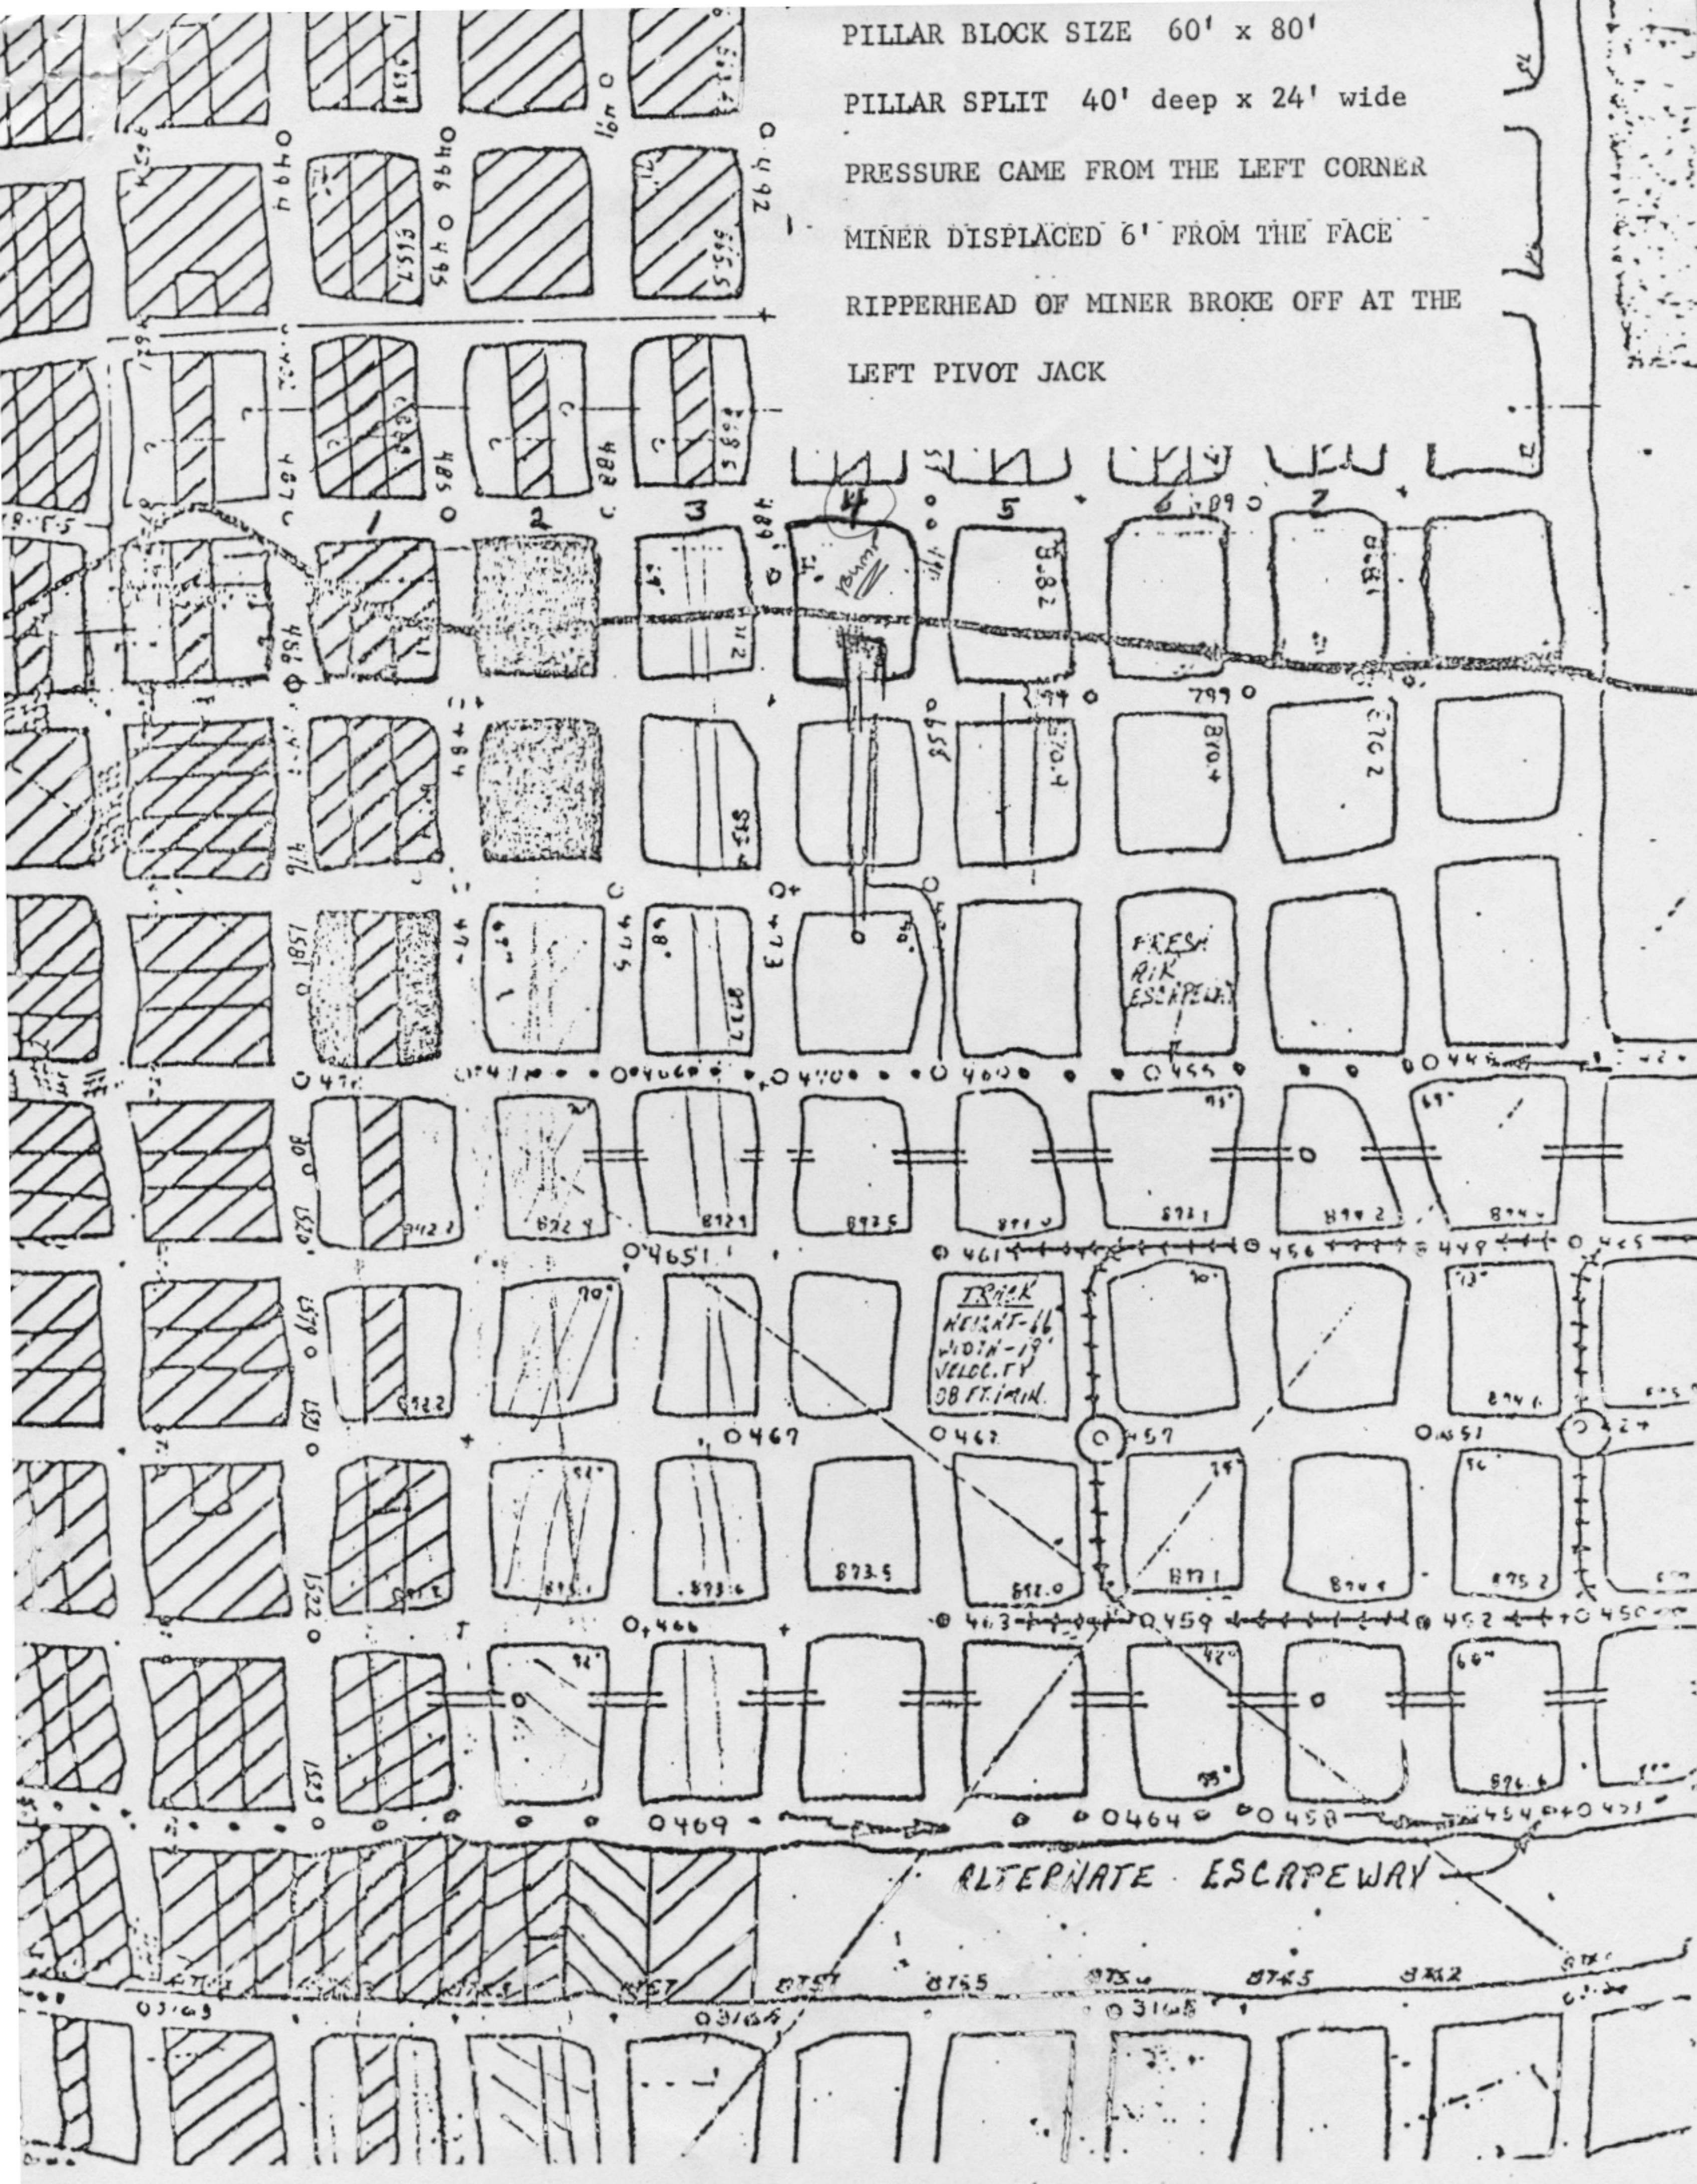
PILLAR BLOCK SIZE 60' x 80'

PILLAR SPLIT 40' deep x 24' wide

PRESSURE CAME FROM THE LEFT CORNER

MINER DISPLACED 6' FROM THE FACE

RIPPERHEAD OF MINER BROKE OFF AT THE

LEFT PIVOT JACK

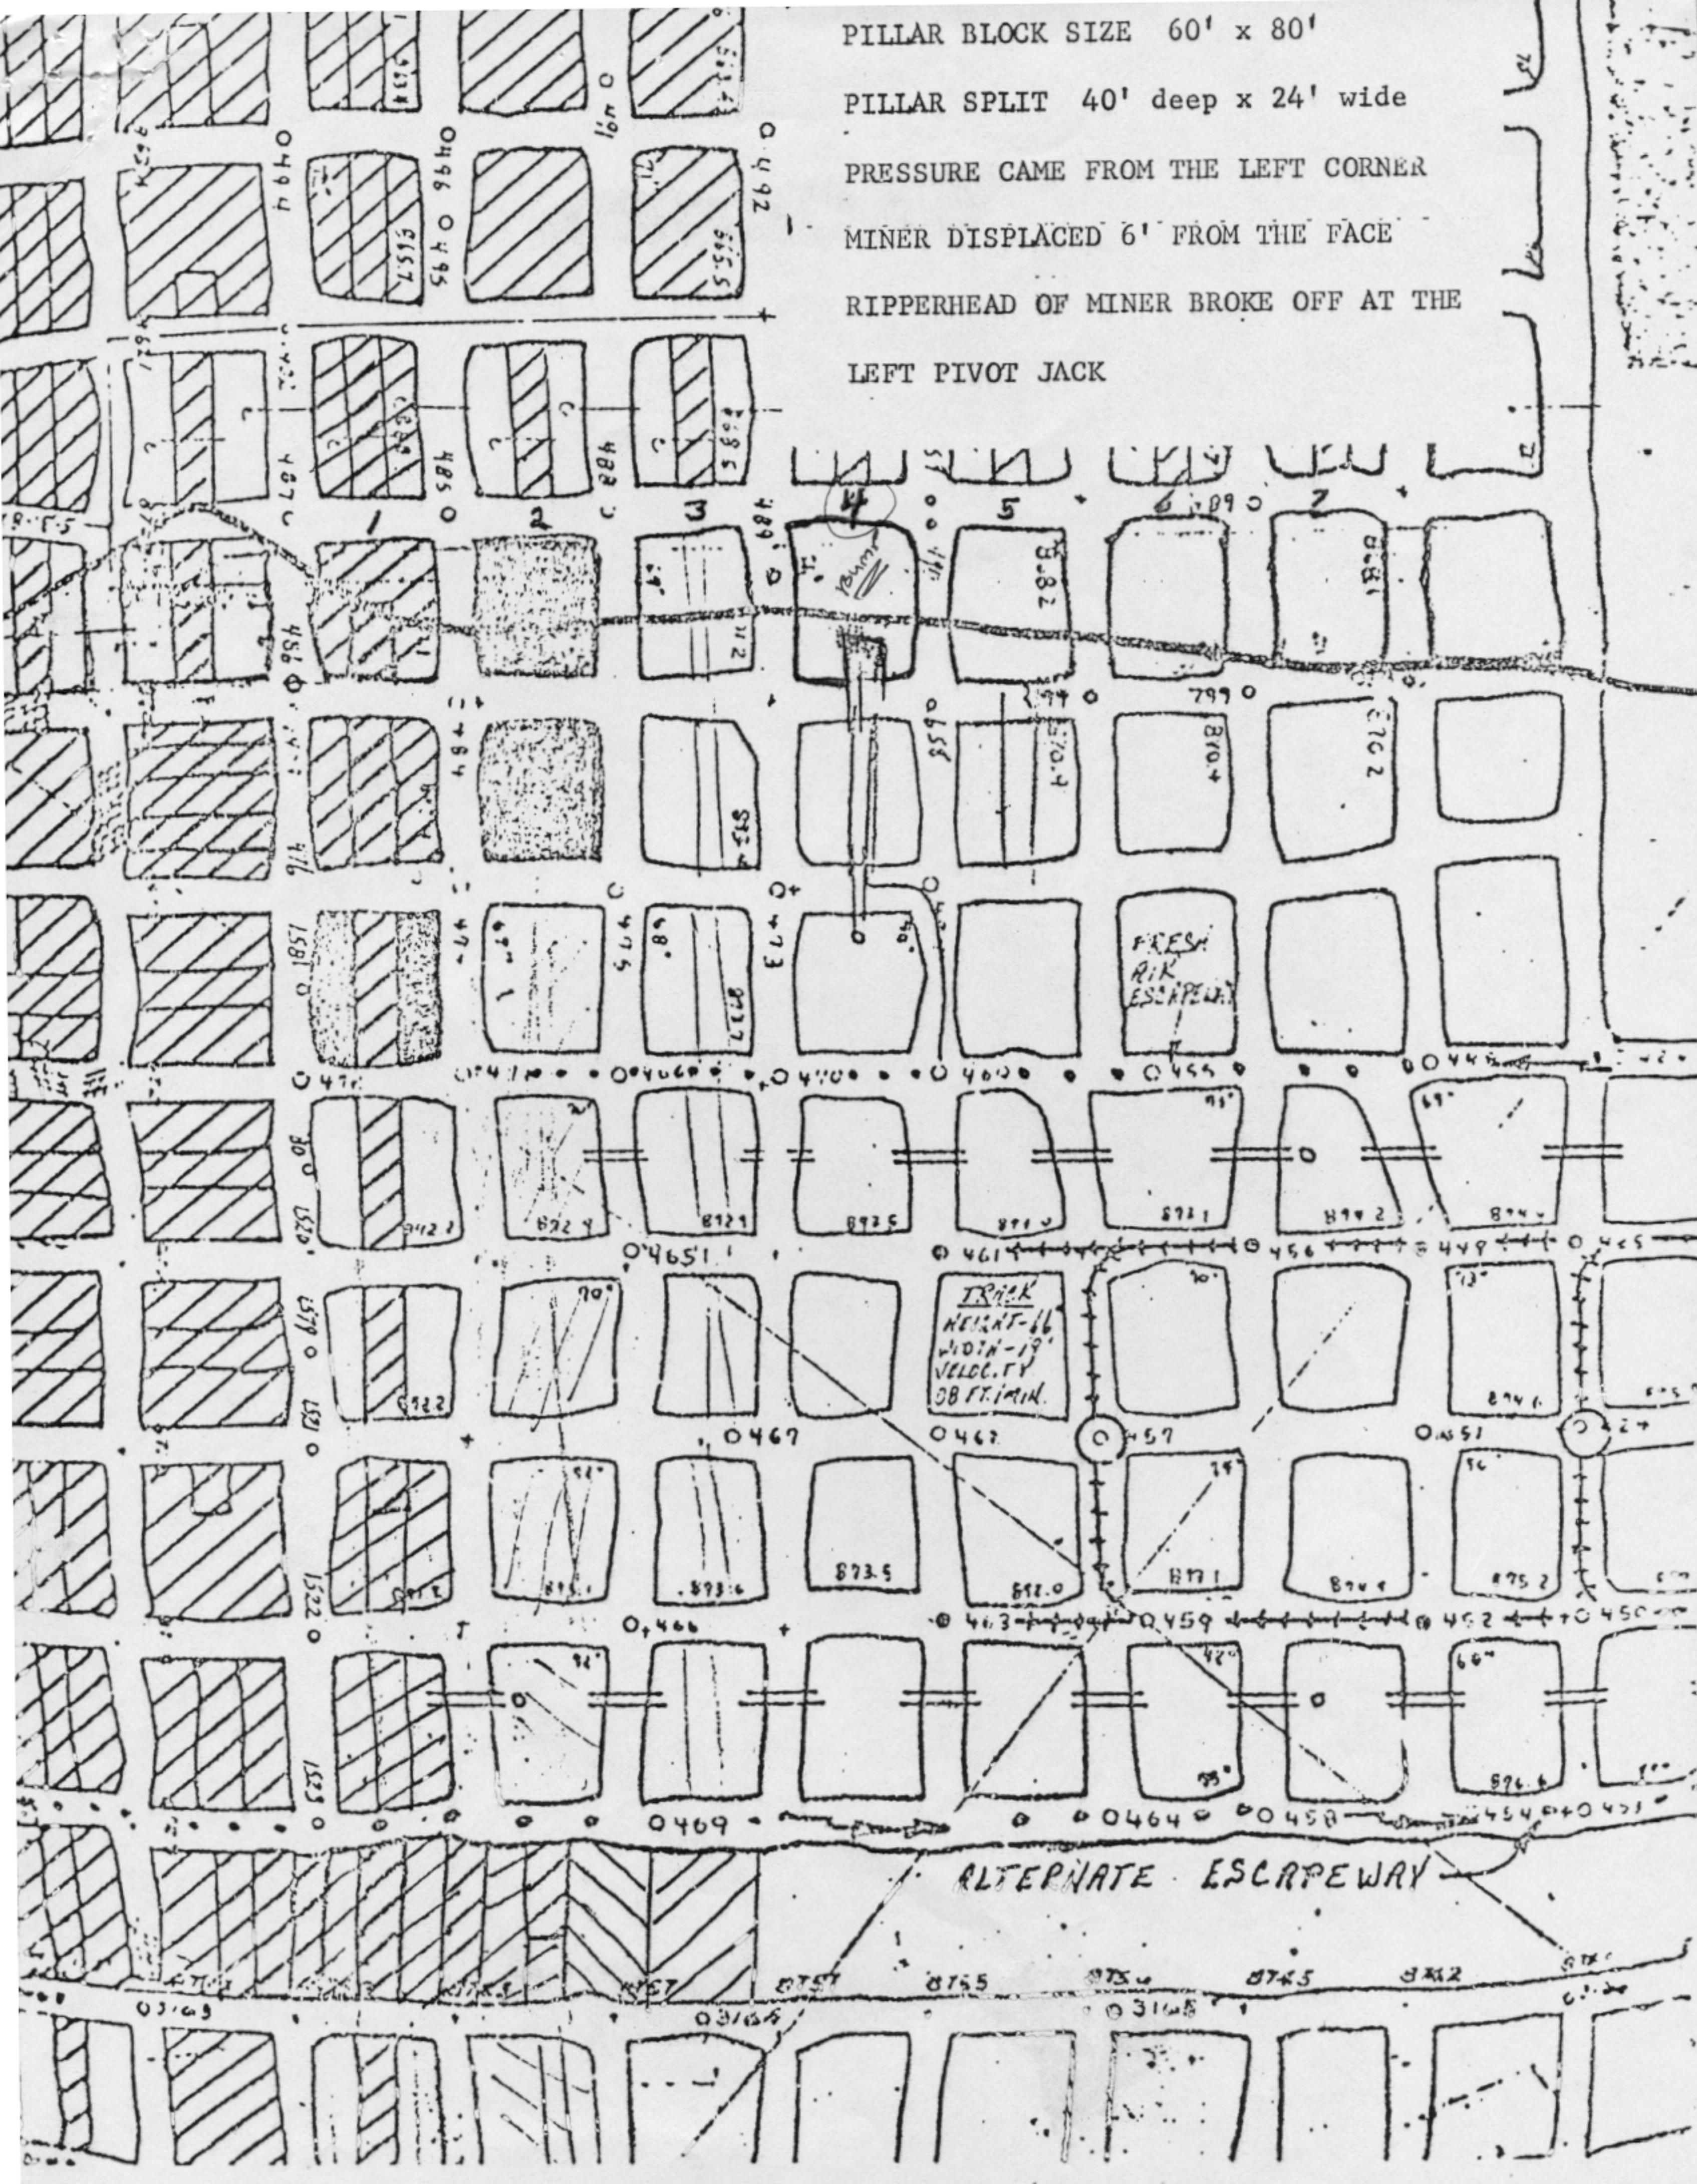
outburst occurred was of normal size, and the condition of the surrounding blocks would not have indicated a pressure buildup in the block.

The immediate roof was sandstone and the main roof was sandstone. The overburden above the pillar block was approximately 1,230 feet.

PILLAR BLOCK SIZE 60' x 80'

PILLAR SPLIT 40' deep x 24' wide

PRESSURE CAME FROM THE LEFT CORNER

MINER DISPLACED 6' FROM THE FACE

RIPPERHEAD OF MINER BROKE OFF AT THE

LEFT PIVOT JACK
